Waterless Printing Trouble shooting Guide

Background Toning

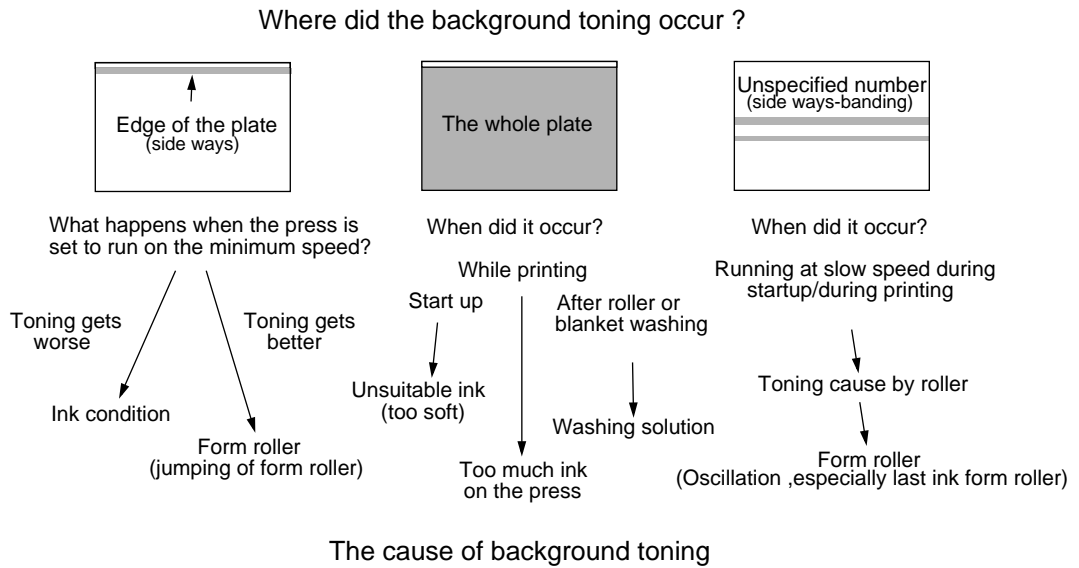
How to distinguish the cause of background toning

Refer to the following chart and distinguish the cause of background toning

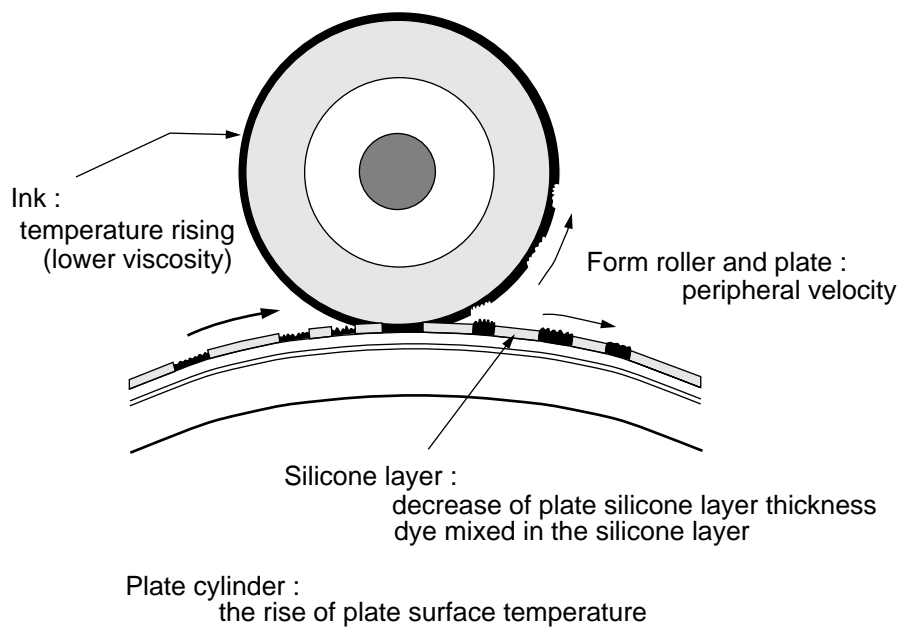
The picture of how background toning occurs

Toning at the gripping edge

Cause The ink viscosity becomes too low due to high press temperature.

Cause Form roller is bouncing near the gripping edge of the plate cylinder.

Cause Plate packing or blanket packing is not fixed in the right position, and there is a crease at the gripping edge. (When paper is used as packing).

Cause Plate flapping at gripping edge.

Solution Exchange the ink to high viscosity type, or decrease the temperature of the press by decreasing the temperature of either the cooling water or the room temperature.

Solution Reduce the nip pressure of the particular form roller whose pressure is too high.

Solution Change the packing paper with a new one.

Solution Check if the plate grip is tight, and adjust if not.

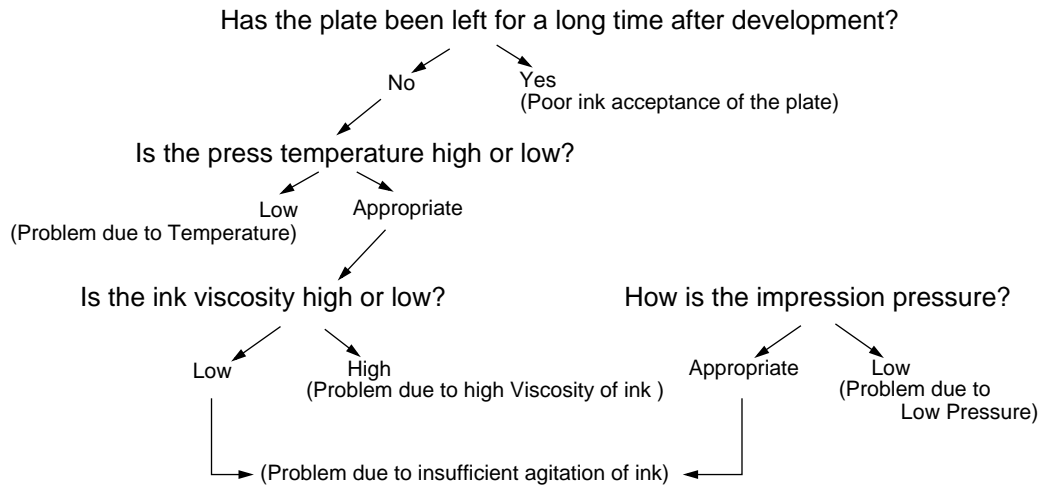
How to distinguish the cause of poor ink laydown

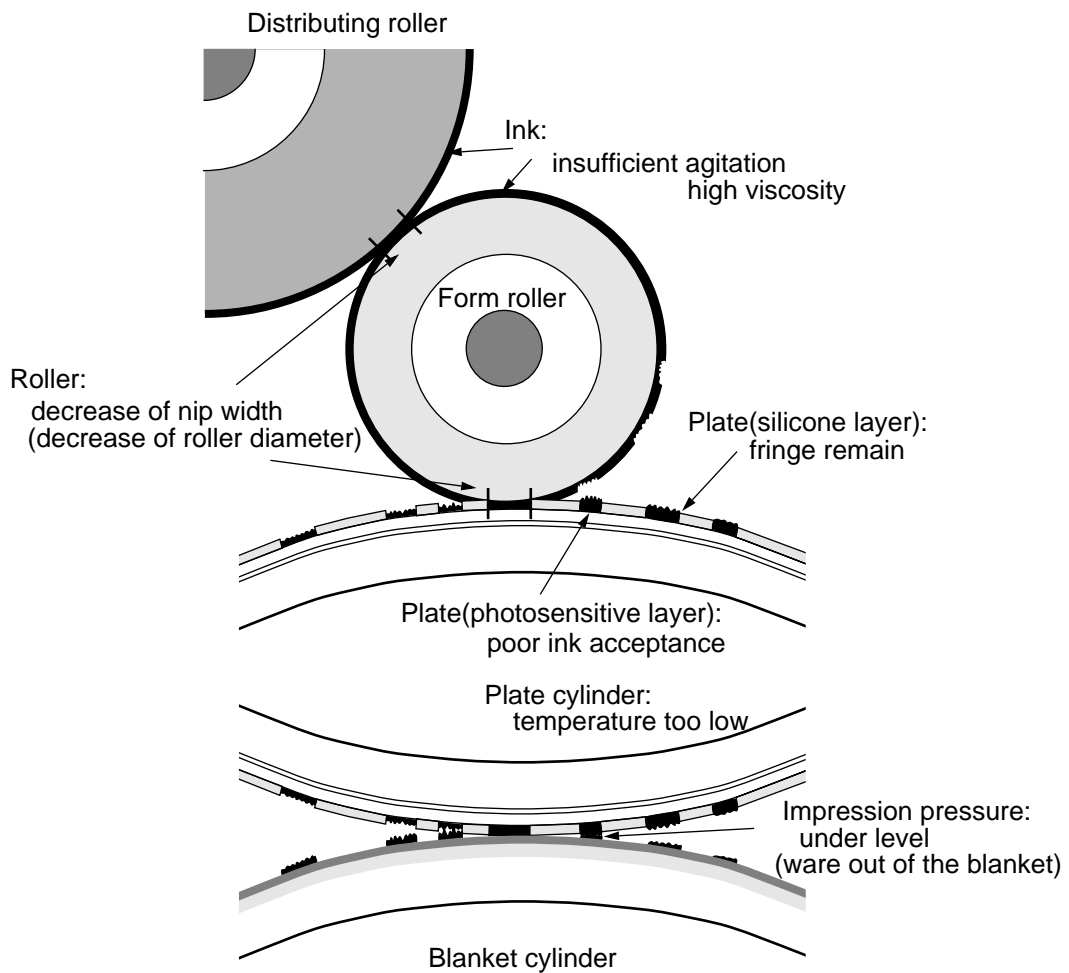
The picture of how poor ink laydown occurs

Poor ink lay down in the shadow area

Cause High ink viscosity, ink dries on the press.

Cause The ink viscosity is too high (ink is unsuited for the press temperature).

Cause Low impression pressure due to wear out of blanket and packing paper.

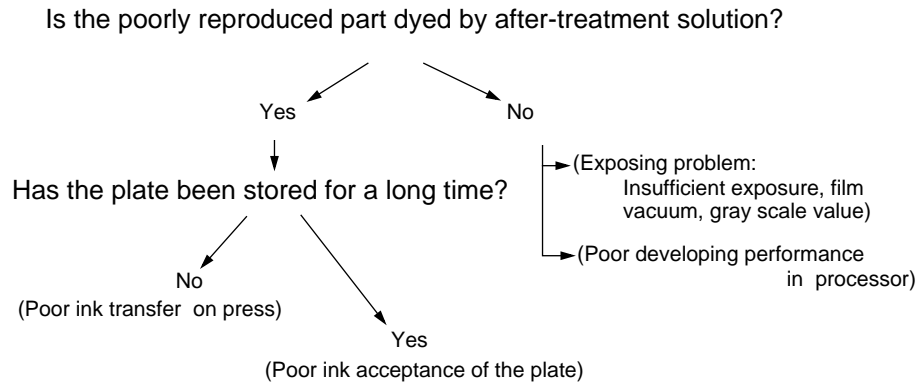
How to distinguish the cause of poor dot reproduction

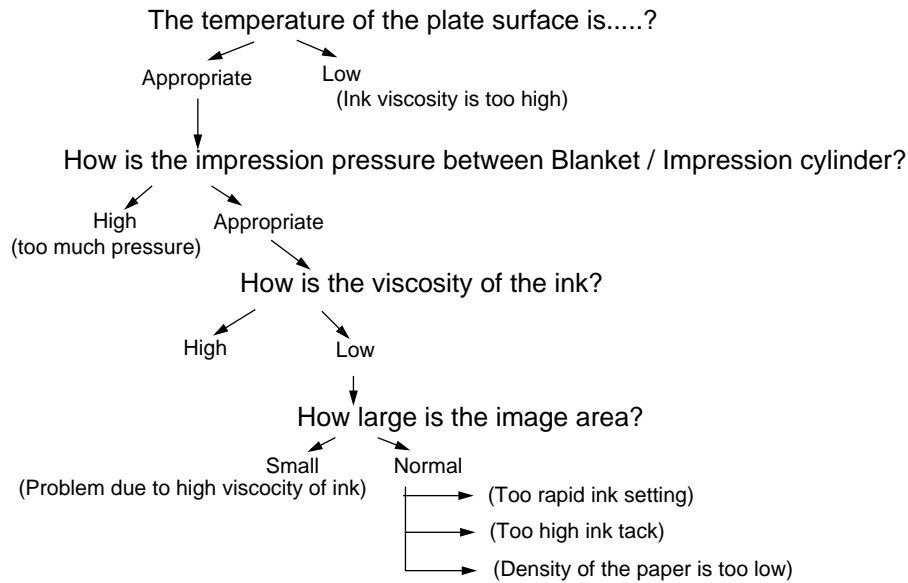
How to distinguish the cause of paper picking and edge picking

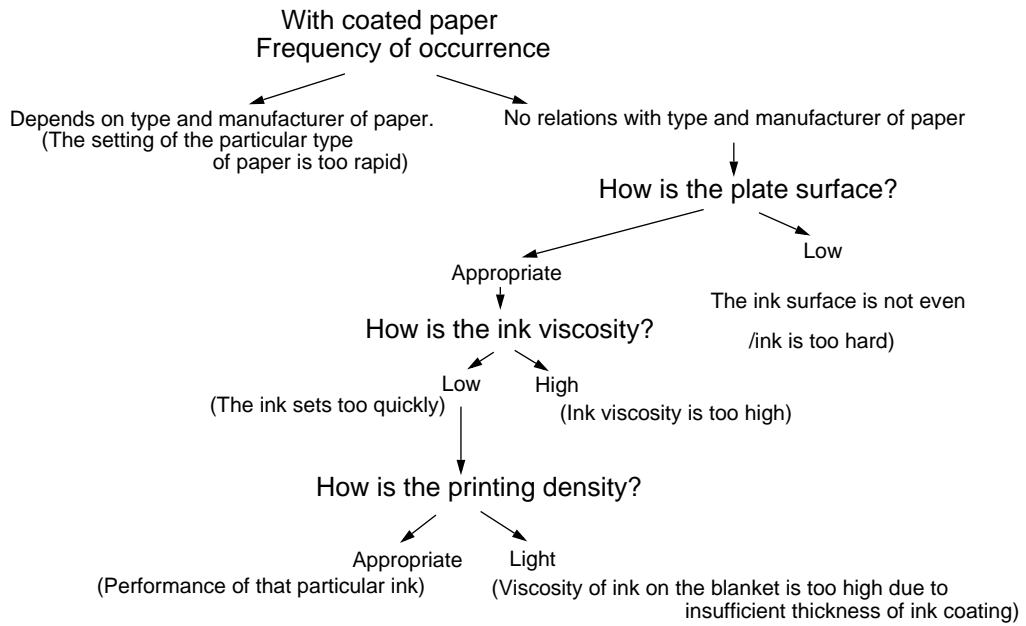
How to distinguish the cause of poor gloss

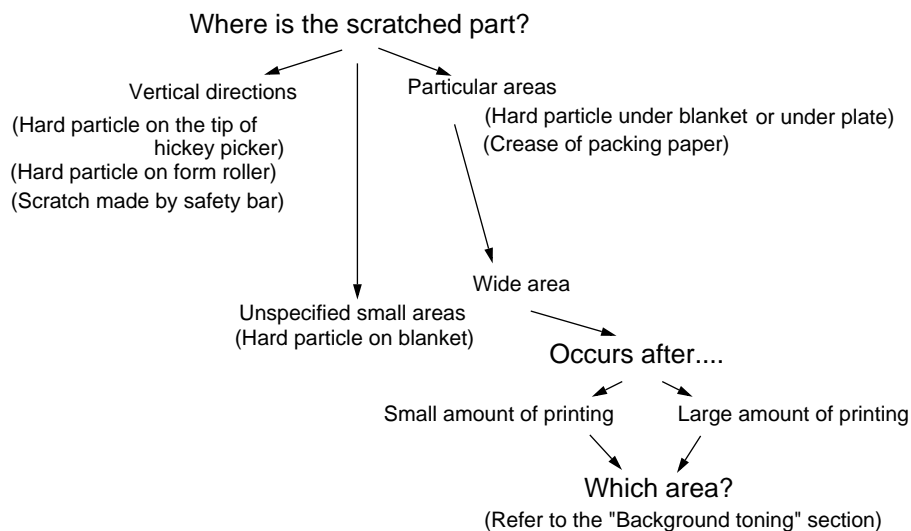
How to distinguish the cause of scratches

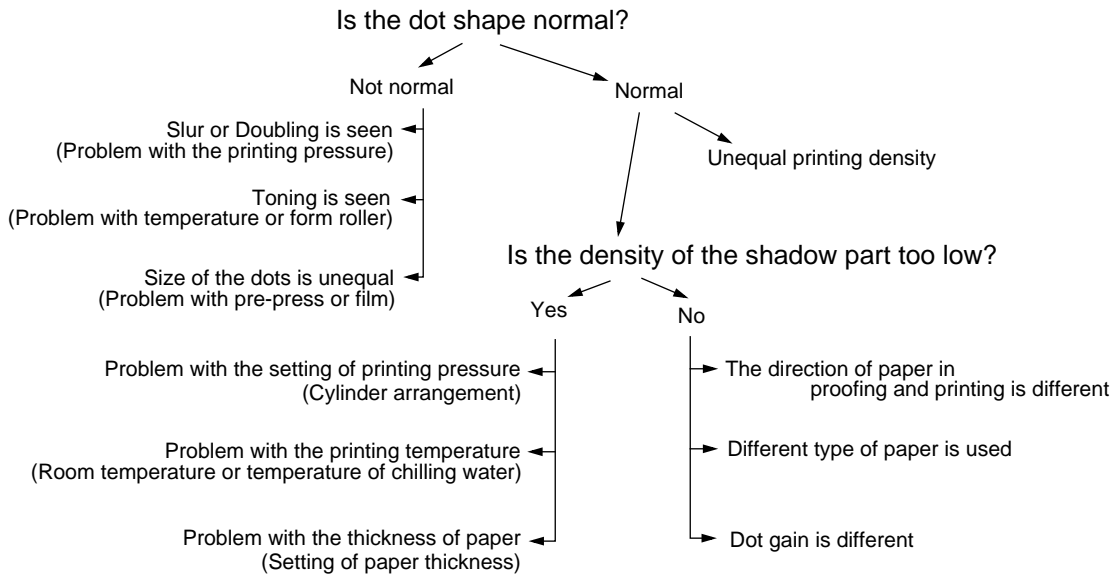
How to distinguish the cause of poor tone reproduction

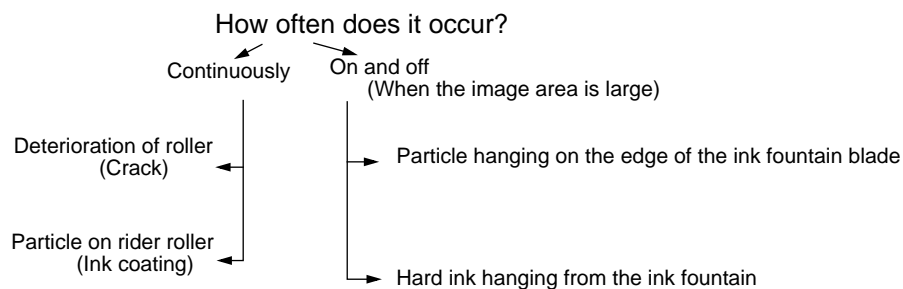
How to distinguish the cause of hickey

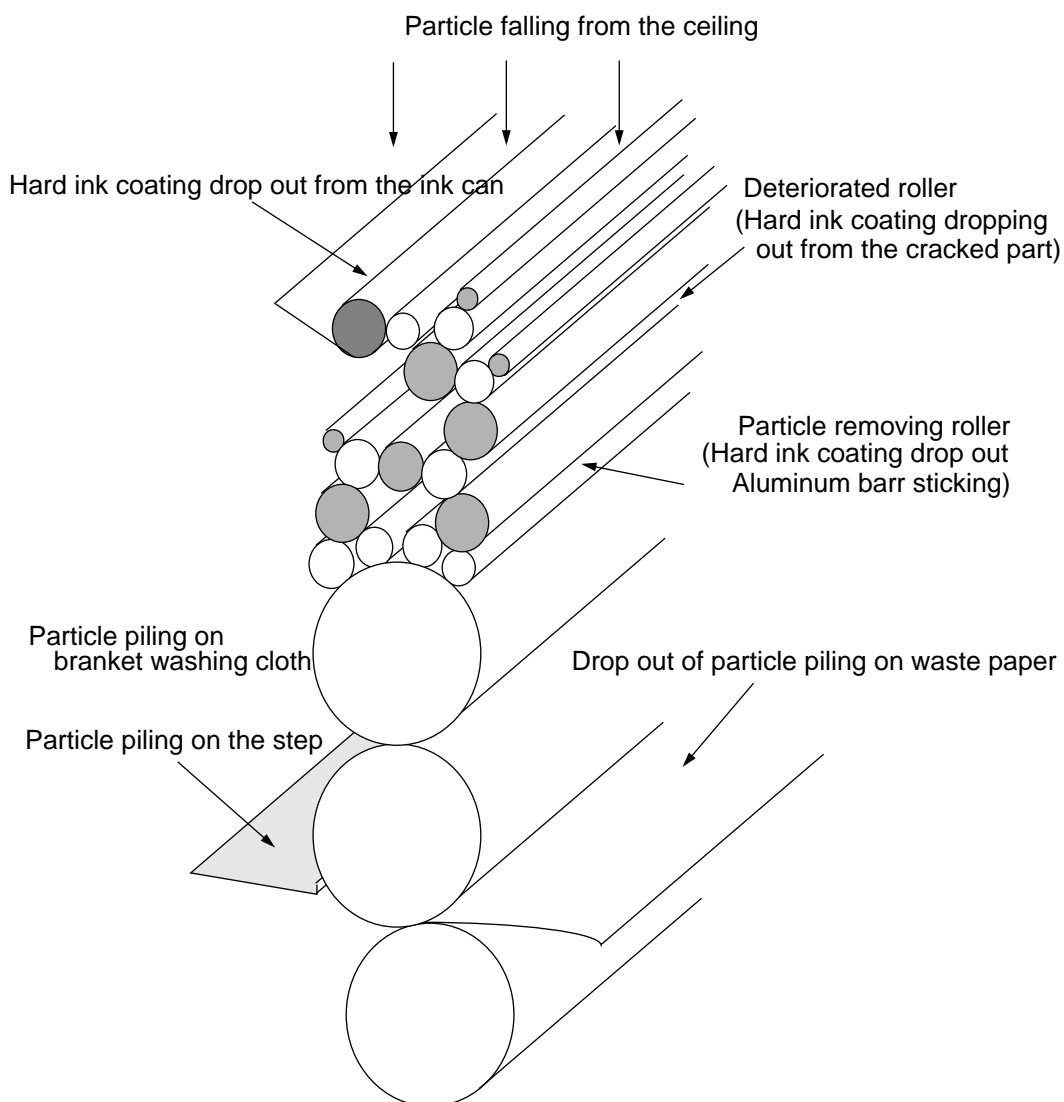
Cause of hickey

Hickey

Cause Hickeys occur in many places right after converting to a job with large image area

Cause Small hickeys are seen continuously.

Cause Both large and small hickeys are seen on and off

Cause Coating of the paper is peeled off.

Solution This occurs when there are many particles piling on the rider roller. Sometimes it is caused by particles in the ink.
